Army Lodging Wellness Recommendation

Fort Sam Houston

August 12, 2003

Section 1 Wellness Recommendation

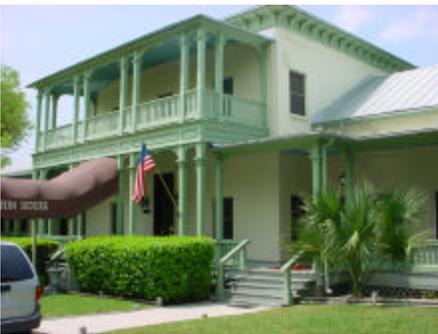
Lodging Building 48

Building 48, the Sam Houston House, was originally constructed in 1886 as the Installation Hospital. It now houses 11 DVQ suites. Although this building has been well preserved, the suites exceed current Army Lodging size requirements. The cost to make improvements and to bring this facility up to Army Lodging standards will exceed the 50% replacement cost.

Our recommendation is to remove building 48 from the Lodging inventory, allowing the installation to determine an alternate use for this facility. This facility will be removed from the Fort Sam Houston Wellness Solution and Lodging Master Plan.

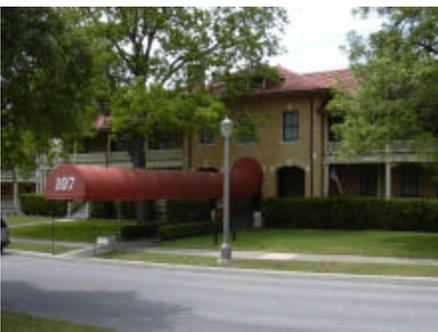
Lodging Building 107

Building 107, the Foulis House, was originally constructed in 1908 as bachelor officer quarters. In 1977 it was re-designated as 13 DVQ suites. Although this building has been well preserved, the suites exceed current Army Lodging size requirements. The cost to make improvements and to bring this facility up to Army Lodging standards will exceed the 50% replacement cost.

Our recommendation is to remove building 107 from the Lodging inventory, allowing the installation to determine an alternate use for this

facility. This facility will be removed from the Fort Sam Houston Wellness Solution and Lodging Master Plan.

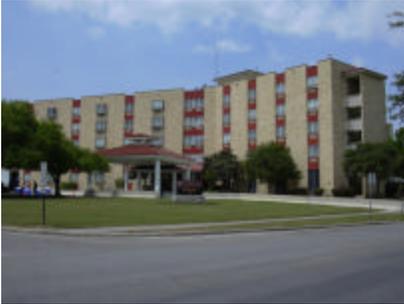
Lodging Building 592

Building 592, built in 1974, is currently the main lodging facility for Fort Sam Houston. It contains most of the administrative, check-in, and back-of-house functions for lodging at the installation. Although its 200 standard rooms meet most of the for Army Lodging standards, many of the buildings systems are approaching the end of their useful lives. Although the cost to make condition assessment improvements is just over the 50% replacement cost, it is our recommendation to remove this facility from the lodging inventory due to the age of the building and building systems.

Our recommendation is to remove building 592 from lodging inventory, allowing the installation to determine an alternate use for this facility. This facility will be removed from the Fort Sam Houston Wellness Solution and Lodging Master Plan.

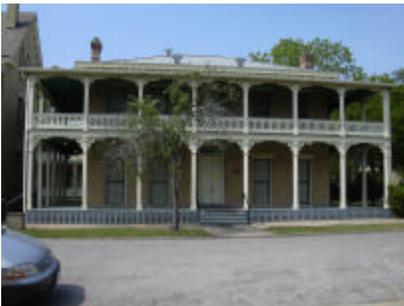
Lodging Buildings 616, 617, 688

These three buildings were constructed at the turn of the 20th century. Building 616 has 4 lodging rooms; building 617 has 20 lodging rooms, and building 688 has 10 lodging rooms. Although these historic buildings have been well preserved, they do not meet current Army Lodging standards. The cost to make improvements and to bring this facility up to Army Lodging standards will exceed the 50% replacement cost.

Our recommendation is to remove buildings 616, 617, and 688 from the Lodging inventory, allowing the installation to determine alternate uses for these facilities. These facilities will be removed from the Fort Sam Houston Wellness Solution and Lodging Master Plan.

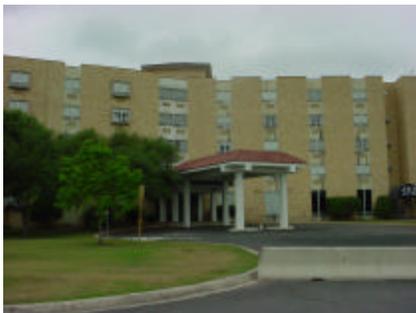
Lodging Building 1384

Building 1384, built in 1974, contains 300 standard rooms. Although these rooms meet most of the Army Lodging standards, many of the building's systems are approaching the end of their useful lives. Although the cost to make condition assessment improvements is just over the 50% replacement cost, it is our recommendation to remove this facility from the lodging inventory due to the age of the building and building systems.

Our recommendation is to remove building 1384 from the Lodging inventory, allowing the installation to determine an alternate use for this

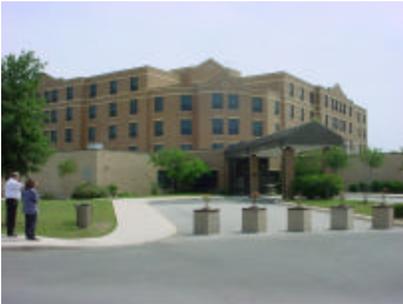
Lodging Building 3625

Building 3625 was built in 1998 and consists of 120 extended stay rooms and 30 family suites. As noted in the Facility Assessment, this building is in excellent condition. The room configurations in this facility come very close to Army Lodging standards. The suites are approximately 468 square feet each, while the single rooms are approximately 315 square feet each.

Our recommendation is to retain building 3625 in the Fort Sam Houston Lodging inventory. This facility will remain in the Fort Sam Houston Wellness Solution and Lodging Master Plan.

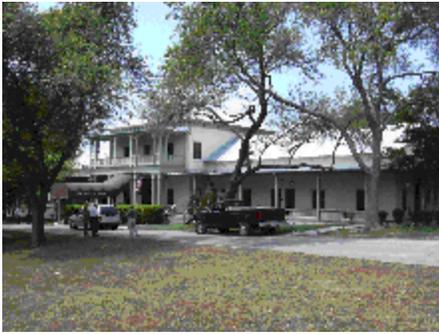
*Building 48
48 Staff Post Road*

Because the Renovation to Replacement Cost Ratio is greater than 50%, renovation of Building 48 is not recommended.

- Analysis: All guest room and common area wall surfaces are covered with a high grade vinyl wall covering. The vinyl is in fair condition and starting to show signs of wear.
- Recommendation: Replace all vinyl wall coverings.

- Analysis: Carpet is located in guest rooms and public areas. It is in fair condition. All bathrooms have ceramic tile floors that are in good condition.
- Recommendation: Replace carpet.

- Analysis: All ceilings in guest rooms and public areas are painted drywall or plaster. The paint is in fair condition.
- Recommendation: Repaint all interior ceilings.

- Analysis: Hot water is provided by a gas fired boiler and a 200 gallon hot water storage tank. The copper pipe delivery system is old and worn. The entire system is beyond its' useful life.

- Analysis: Air conditioning to the building is provided by a chilled water circulating system with individual room damper controls. The system is inadequate and in poor condition.

- Recommendation: Replace the domestic water system.

- Recommendation: Replace the air conditioning system with a new multi-zone system with individual room controls.

- Recommendation: Install sprinkler system as required by code.

- Recommendation: Replace main service and panel to handle increased electrical loads. Replace branch circuits, electrical outlets and lighting.
