# Army Lodging Wellness Recommendation

## Redstone Arsenal - Final Submittal

August 18, 2003

# Section 1 Wellness Recommendation

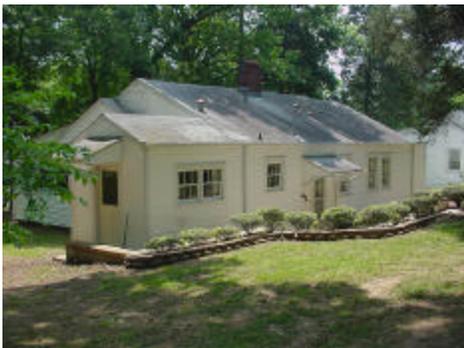
### ***Lodging Buildings 55, 56, 58, 60 and 62***

Buildings 55, 56, 58, 60, and 62, constructed in 1942, are typical residential construction, and include 3 bedrooms, kitchen, dining and living areas in each building. These facilities are currently used as Distinguished Visitor Quarters (DVQ) with parking directly across the street from the rooms.

These buildings are in good condition as indicated on the Facility Assessment, but do not meet the lodging size requirements. Converting these rooms to Army Lodging standards will exceed the 50% replacement cost.

Our recommendation is to remove buildings 55, 56, 58, 60, and 62 from the Lodging inventory, allowing the installation to determine an alternate use for these facilities. These facilities will be removed from the Redstone Arsenal Wellness Solution and Lodging Master Plan.

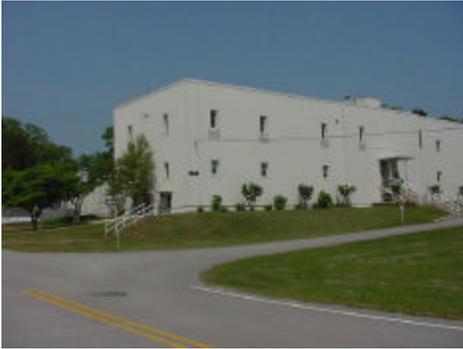
***Lodging Building 111***

Building 111, constructed in 1942, is a shared building with the installation, and contains 4 Distinguished Visitor Quarters (DVQ) functioning as one standard stay and three family suites on the third floor. These rooms are accessed by stair but not elevator. This facility is in good condition, but does not meet current Army Lodging standards. Converting these rooms to Army Lodging standards will exceed the 50% replacement cost.

Our recommendation is to remove building 111 from the Lodging inventory, allowing the installation to determine an alternate use for this facility. This facility will be removed from the Redstone Arsenal Wellness Solution and Lodging Master Plan.

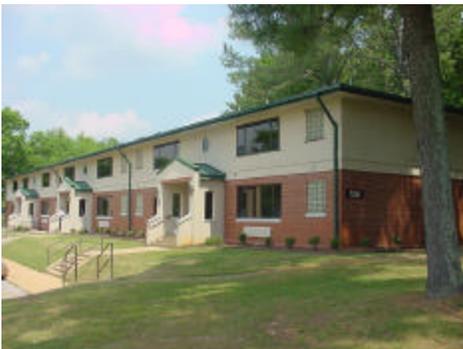
***Lodging Buildings 131, 133 and 135***

Buildings 131, 133, and 135, constructed in the 1960's and extensively renovated in 1998 and 1999, are 2-story buildings currently used for Visitor Quarters. Each building contains a mix of two floor plans; a one-bedroom suite with kitchen and living room, and a single room, half with kitchens. The one-bedroom suites, while being slightly oversized, will be reclassified as family suites (14 total). The remaining 48 single room rooms will be split equally between standard room and extended stay rooms. These facilities are in very good condition

Our recommendation is to retain buildings 131, 133, and 135 in the Redstone Arsenal Lodging inventory. These facilities will remain in the Redstone Arsenal Wellness Solution and Lodging Master Plan.

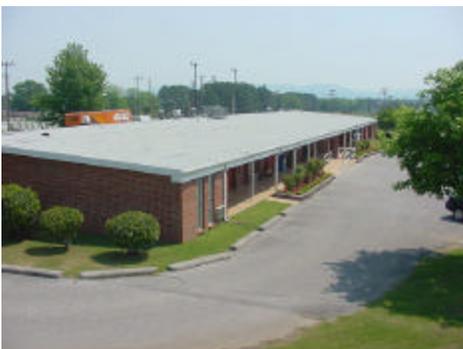
***Lodging Building 244***

Building 244, constructed in 1972 and recently renovated, serves as the primary Lodging office. This facility currently houses 24 rooms, including 20 standard rooms (four being used as offices) and 4 extended stay rooms, which meet current Lodging standards and are in good condition. The public areas and back-of-house areas, though, do not meet standards, and our recommendation is to relocate these functions to the proposed new Lodging facility.

Our recommendation is to retain building 244 in the Redstone Arsenal Lodging inventory. This facility will remain in the Restone Arsenal Wellness Solution and Lodging Master Plan.

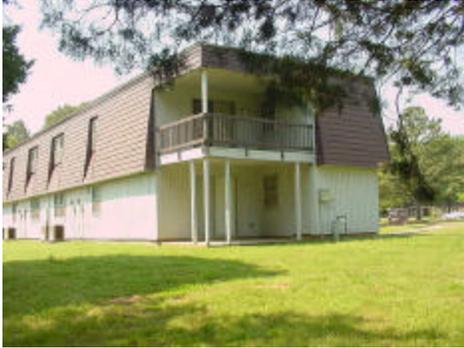
***Lodging Buildings 1400, 1416, 1417, 1418, 1419, 1420, 1421, 1422, 1423, 1424, 1426, 1427, 1428, 1429, 1430, 1433, 1434, 1435, 1436 and 1437***

These 20 Lodging buildings, constructed in 1972, are clustered in an area less than one mile from the primary Lodging office, building 244. Consisting of two different 2-story floor plans, each building contains four 2-bedroom apartments with kitchen, bath and living room. Eight of the rooms have exterior stair access to the top floor while the other twelve have interior stair access. Some minor renovations have been made to the exteriors of the buildings over the years, but all still remain in poor condition. One building has been abandoned because of roof truss failure, and all roofs sag noticeably. All of these buildings are in poor condition and do not meet the current Army Lodging standards. The cost to make condition assessment improvements will exceed the 50% replacement cost.

Our recommendation is to remove these buildings from the Lodging inventory, allowing the installation to determine an alternate use for these facilities. These facilities will be removed from the Redstone Wellness Solution and Lodging Master Plan.

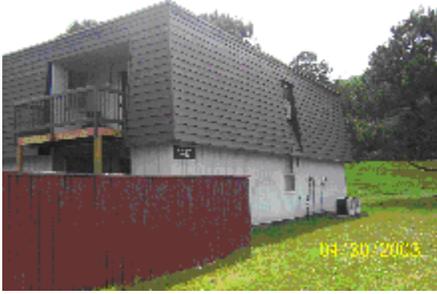
Bldg. # 1417 typical of 1400 series.

Building 1400 was constructed in 1972 as a family housing Quadraplex unit with a total of 4,860 square feet. It is currently operating as four family suites each with full kitchens.

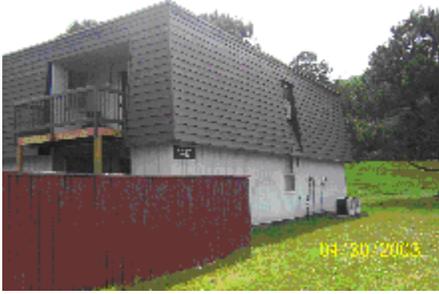
Bldg. 1417

Building 1417 was constructed in 1972 as a family housing Quadraplex unit with a total of 4,860 square feet. It is currently operating as four family suites each with full kitchens.
