Army Lodging Wellness Recommendation

Fort Rucker - Final Submittal

August 19, 2003

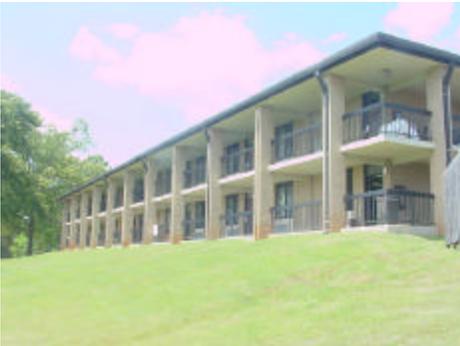
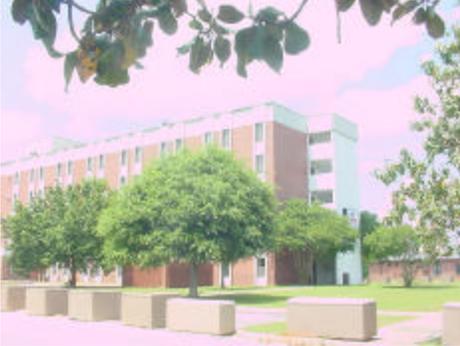
Lodging Building 125

Building 125, constructed in 1987, is a 2-story building, currently housing 38 single rooms with kitchens, and is used as the guest house for families. The rooms are accessed directly from the exterior, either from grade or exposed balcony. There is a playground adjacent to the building. The building nearly meets Army Lodging standards for standard room and extended-stay room configurations. The cost to make condition assessment improvements and renovations will not exceed the 50% replacement cost.

Our recommendation is to retain building 125 in the Fort Rucker Lodging inventory. This facility will remain in the Fort Rucker Wellness Solution and Lodging Master Plan.

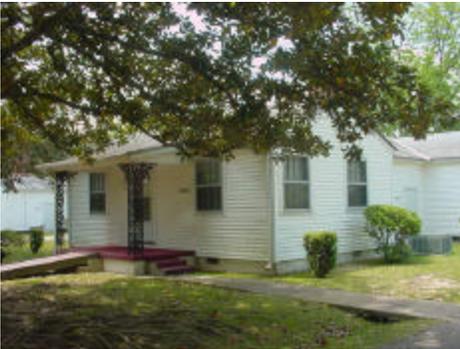
Lodging Buildings 202 and 204

These two buildings, known as Camellia House and Magnolia House, are both single room 1-story residential rooms, constructed in 1942, and have possible historic significance. Currently serving as Distinguished Visitor Quarters for the Installation, Camellia House (building 202) has four bedrooms and a kitchen, and Magnolia House (building 204) has three bedrooms and a kitchen. Camellia House has a covered garage, and Magnolia House has a covered carport, both directly adjacent to the rooms. Although these buildings have been well preserved, they do not meet current Army Lodging standards and size requirements. The cost to renovate to Army Lodging standards will exceed the 50% replacement costs.

Our recommendation is to remove buildings 202 and 204 from the Lodging inventory, allowing the installation to determine an alternate use for these facilities. These facilities will be removed from the Fort Rucker Wellness Solution and Lodging Master Plan.

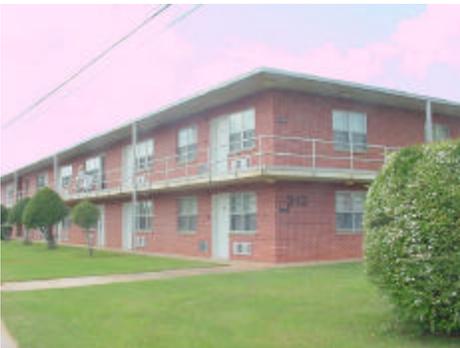
Lodging Buildings 304, 310, 312, 313, and 314

These five buildings, constructed in 1964 and 1965, have received significant renovations and are similar in appearance and construction. These buildings are 2-story structures, with access to the rooms from the exterior, either from grade or from an exposed balcony. Building 304 has 32 extended stay rooms and 8 family suites, for a total of 40 rooms. Buildings 310, 312, 313 and 314 are the same layout as building 304; however, they are used as 20 extended stay rooms and 20 standard rooms, for a total of 40 rooms each. The family rooms are used as standard rooms, and each of the standard rooms include “stubbed out” plumbing for a future kitchenette.

These facilities nearly meet Army Lodging standards for standard room and extended-stay room configurations. The family suites in Building 304 are undersized as family suites, and conversion to extended stay rooms is recommended with minor renovation. In buildings 310, 312, and 314, the renovation of the family rooms to extended stay rooms, and converting the standard rooms to extended stay by adding kitchenettes, would allow the use of the buildings to match the demand requirement for Fort Rucker, with the cost of this renovation not exceeding the 50% replacement cost. Building 313 is in fair condition, but the cost to renovate this building to meet Army demand requirements will exceed the 50% replacement cost. Therefore, this building is recommended for demolition to provide adequate siting for a new 28 room family suite Lodging facility adjacent to the existing Lodging facilities.

Our recommendation is to retain buildings 304, 310, 312, and 314 in the Fort Rucker Lodging inventory. These facilities will remain in the Fort Rucker Wellness Solution and Lodging Master Plan.

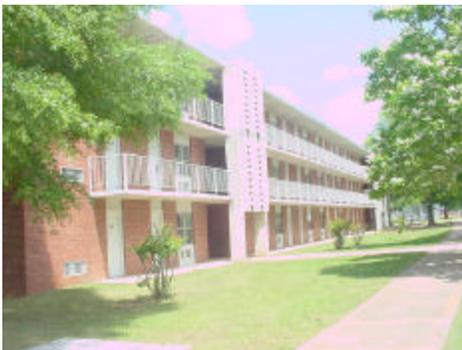
Lodging Building 305

Building 305, constructed in 1971, has received significant renovations, and is in good condition. This 3-story building currently housing 24 extended stay rooms (each with 2 rooms, 2 baths, and a galley kitchen) and 6 DVQ suites (2 rooms, 2 baths, and a galley kitchen), for a total of 30 Lodging rooms. Each floor has an equal number of both types of rooms, and all rooms are accessed from the exterior, either from grade or from an exposed balcony.

Our Wellness Recommendation is renovate support spaces for a secondary facility and convert guest rooms to extended stay rooms to meet the demand requirement for the installation. Rooms will be divided, removing full kitchens and adding kitchenettes to meet Army Lodging standards. Fourteen rooms will be removed from inventory which are in excess of the demand requirements.

Our recommendation is to retain building 305 in the Fort Rucker Lodging inventory. This facility will remain in the Fort Rucker Wellness Solution and Lodging Master Plan.

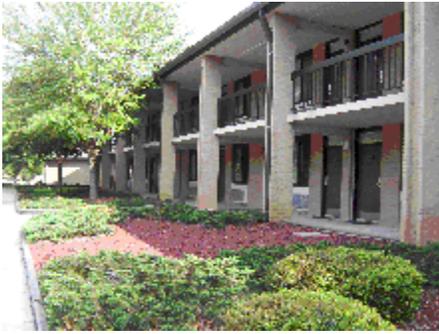
Bldg. 125 Front view

This building is in good condition for both the Condition Assessment and Function Criteria. In this building the Condition Assessment costs include the wellness items and the Renovation Cost includes functional renovations but not Condition Assessment cost due to the limited nature of the renovation. Therefore in the Cost Analysis the sum of the Condition Assessment and Renovation cost is used for the ratio to the Replacement Cost

- Analysis: Gutters are damaged and failing
- Recommendation: Replace gutters

- Analysis: Solid core wood doors, are beyond expected useful life
- Recommendation: Replace with hollow metal door, frame, and associated hardware

- Analysis: Asphalt shingle roofing is beyond expected useful life.
- Recommendation: Replace asphalt shingle roofing

- Analysis: Bathroom fixtures appear to be reaching the end of their useful life, and are in fair condition
- Recommendation: Replace sink and vanity in all guest units.

It should be noted that there appears to be a design/original construction deficiency with the domestic water distribution. Current extent unknown. However, we noted that they had two bathrooms torn apart during our visit. The building is not really old enough to have the system failing.

- Analysis: Above floor system appears to be in good condition. Copper water distribution that is buried under the concrete slab has leaked as a result of the copper piping being eaten away by the contact with the concrete
- Recommendation:

Because the Sum of the Condition Assessment and Renovation Costs to Replacement Cost Ratio is less than 50%, renovation of Building 125 is recommended.
