Army Lodging Wellness Recommendation

Fort Sam Houston

August 12, 2003

Section 1 Wellness Recommendation

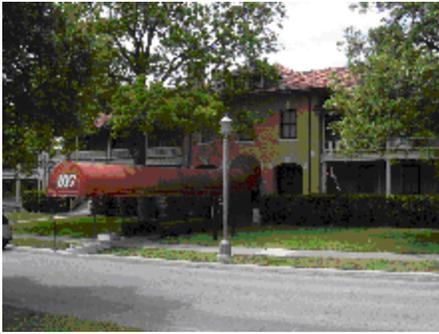
Building 107
107 Artillery Post Road

Building 107, the Foulis House, was originally constructed in 1908 as bachelor officer quarters. In 1977 it was re-designated as 13 DVQ suites. Although this building has been well preserved, the suites exceed current Army Lodging size requirements. The cost to make improvements and to bring this facility up to Army Lodging standards will exceed the 50% replacement cost.

Our recommendation is to remove building 107 from the Lodging inventory, allowing the installation to determine an alternate use for this

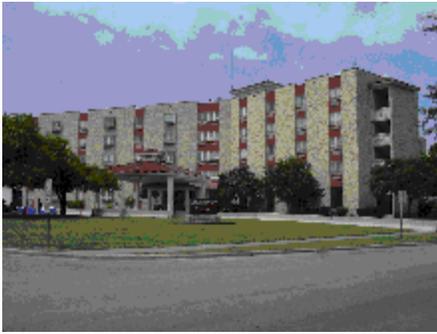
*Building 592
592 Dickman Road*

Our recommendation is to remove building 592 from lodging inventory, allowing the installation to determine an alternate use for this facility. This facility will be removed from the Fort Sam Houston Wellness Solution and Lodging Master Plan.
