# Army Lodging Wellness Recommendation

## Redstone Arsenal - Final Submittal

August 18, 2003

# Section 1 Wellness Recommendation

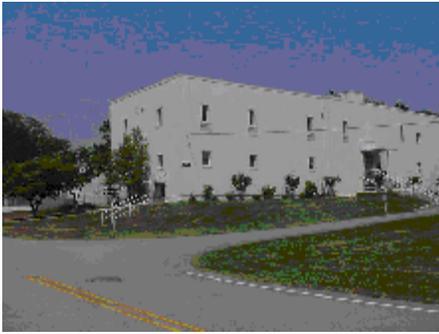
Bldg. 111

Building 111, constructed in 1942, is a shared building with the installation, and contains 4 Distinguished Visitor Quarters (DVQ) functioning as one standard stay and three family suites on the third floor. These rooms are accessed by stair but not elevator. This facility is in good condition, but does not meet current Army Lodging standards. Converting these rooms to Army Lodging standards will exceed the 50% replacement cost.

Our recommendation is to remove building 111 from the Lodging inventory, allowing the installation to determine an alternate use for this facility. This facility will be removed from the Redstone Arsenal Wellness Solution and Lodging Master Plan.

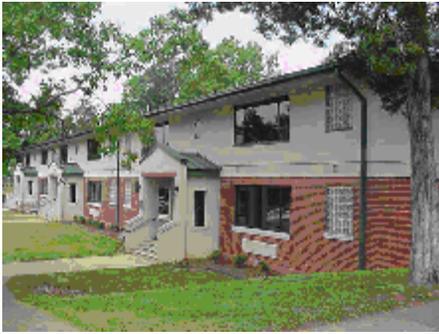
Bldg. 135

Buildings 131, 133, and 135, constructed in the 1960's and extensively renovated in 1998 and 1999, are 2-story buildings currently used for Visitor Quarters. Each building contains a mix of two floor plans; a one-bedroom suite with kitchen and living room, and a single room, half with kitchens. The one-bedroom suites, while being slightly oversized, will be reclassified as family suites (14 total). The remaining 48 single room rooms will be split equally between standard room and extended stay rooms. These facilities are in very good condition

Our recommendation is to retain buildings 131, 133, and 135 in the Redstone Arsenal Lodging inventory. These facilities will remain in the Redstone Arsenal Wellness Solution and Lodging Master Plan.

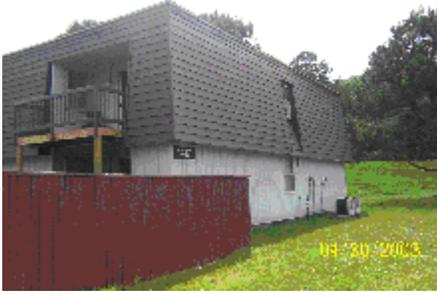
Building 1416 was constructed in 1972 as a family housing Quadraplex unit with a total of 4,860 square feet. It is currently operating as four family suites each with full kitchens.
