Army Lodging Wellness Recommendation

Fort Rucker - Final Submittal

August 19, 2003

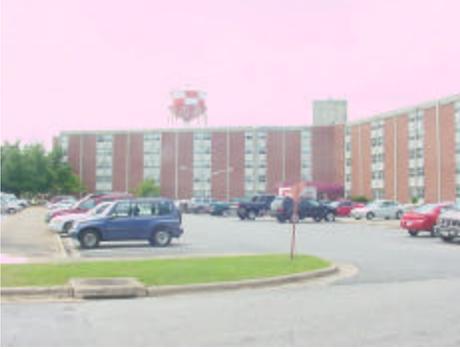
Lodging Building 308

Building 308, constructed in 1969, has received significant renovations and is in good condition. This 5-story building currently serves as the primary Lodging office for the installation. This facility includes public areas and back-of-house functions, including a check-in desk, administrative spaces, and a dining hall, serving all adjacent Lodging facilities.
